THE ZEUGMA WALL PAINTINGS
STUDY AND RECOVERY OF THE ROMAN DECORATIONS

Y. Selçuk Şener, Bekir Eskici, and Cengiz Çetin

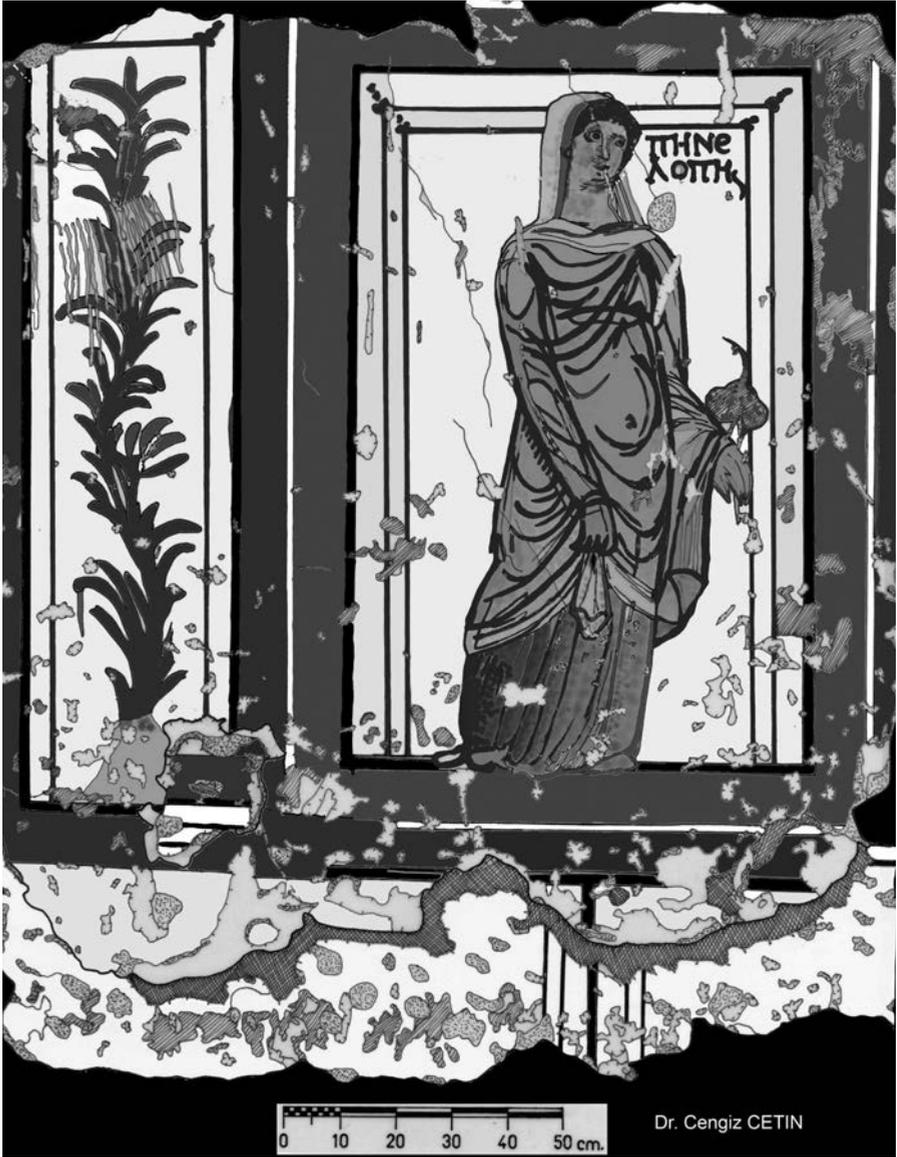
Fig. 1. Room P26, east wall (drawing: C. Çetin).

(1) Pigmented Graffiti: These graffiti are the inscriptions next to human figures, written just to the right of the person's head with cream coloured pigment using a brush. The name *Penelope* is found on the east wall of Room P26 (Fig. 1).

1st group: This subgroup is composed of parallel short lines in various numbers. A diagonal line longer than the others is drawn over some groups. The parallel lines seem to have been served as a kind of tally sticks (Fig. 1).

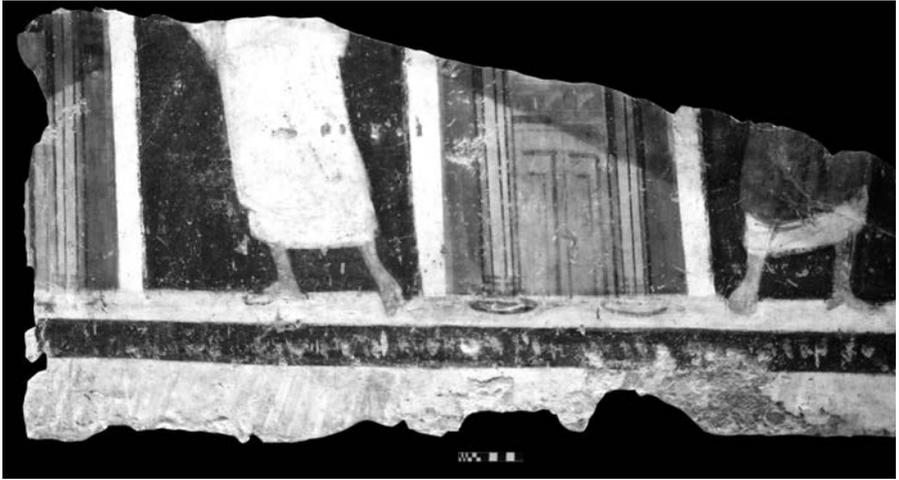
Fig. 2. Room P11, north wall (photo: C. Çetin).

The second composition in Room P11 is also typical of the art of the Severan Period, with plump human figures depicted only with exterior contours and without details between columns. Details are expressed through the contrast of dark and light tones in front of buildings and are pictured with exterior contours only (Fig. 2). This composition is a provincial parallel to the wall painting in the *Domus Praeconum* (Herald's Home: Ling 1991, 187, pl. 203) on the Palatine in Rome, dated to the second half of the 3rd century AD (Dorigo 1966, pl. 87). On the basis of their general features, the compositions of the wall paintings of Zeugma Terrace A seem to date to a time span between the 3rd and the end of the 4th century AD. This date would corroborate the mid 3rd century destruction date of Zeugma.

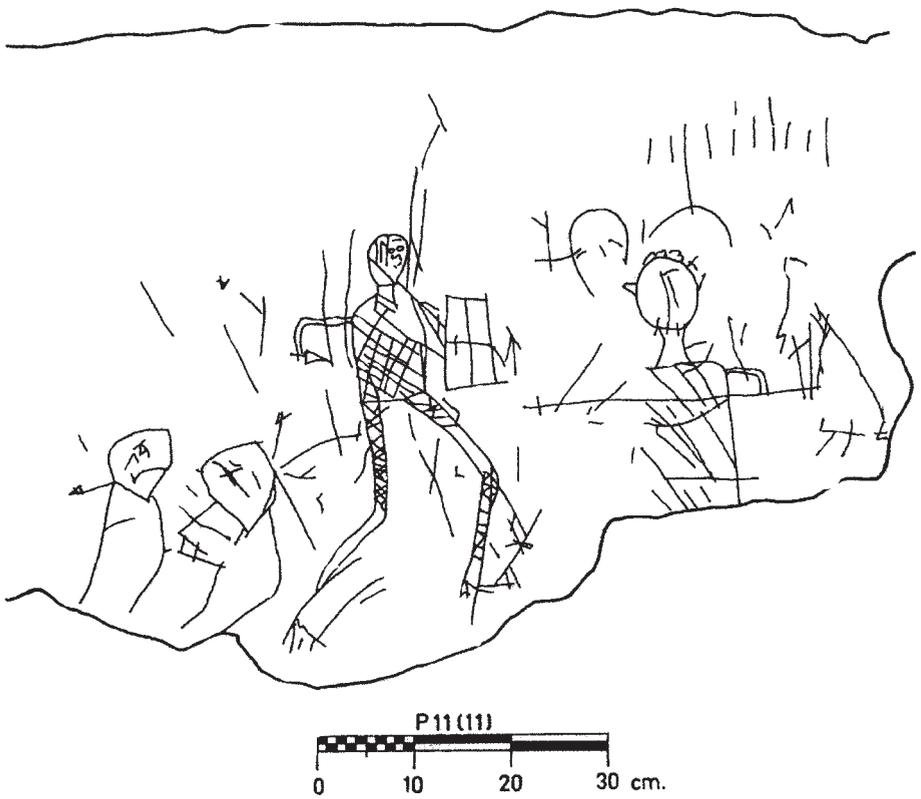
Fig. 3. Room P11, graffiti on the painting on the south wall (drawing: C. Çetin).

b- Figural Graffiti: These graffiti depict human figures (Fig. 3) and animals. The figures are usually filled with hatching. Except for the feeding bird on a painting on the north wall of Room P12, no animal graffiti has a narrative theme. The animals depicted include a horse, a bird, and a fish. The graffiti with human figures do not have a specific theme either. A gladiator game is depicted on the south wall of Room P11. Such gladiators can be seen in many ancient sites (Allag/Barbet 1975, 44-46, pl. 7a-c, fig. 30-32), e.g. on the west wall of Ephesus Room 38d (Krinzinger 2002, pl. 20 fig. 53);

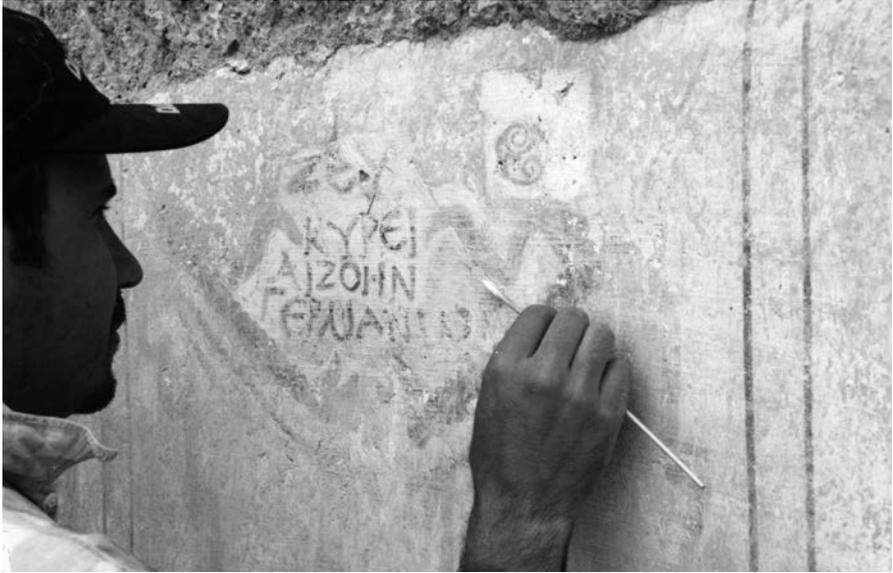
Fig. 4. Surface cleaning before lifting (photo: S. Şener).

In preparation for the lifting and the subsequent study of the mosaics, the post-depositional layers on the smooth plaster and the pigmented surfaces were removed by either dry (mechanic) or wet cleaning. Prior to this process, shelters were made over the walls to avoid exposure of the surfaces of the wall paintings to the sunlight. The layers of dust and clayey soil were removed from the surfaces of the wall paintings with various spatulas, bamboo sticks, and brushes. Those with mud, burnt soil, and ashy layers were first cleaned mechanically with brushes and the remaining layers of dirt were wiped from the surface with damp sponges soaked in water. On the thinner muddy layers, the surface was cleaned with damp cotton tipped bamboo sticks (Fig. 4). The utmost care was taken to carry out this application without damaging the pigmented surfaces or lifting the pigment. Dry cleaning was limited where the pigments are fragile and flaking was observed.

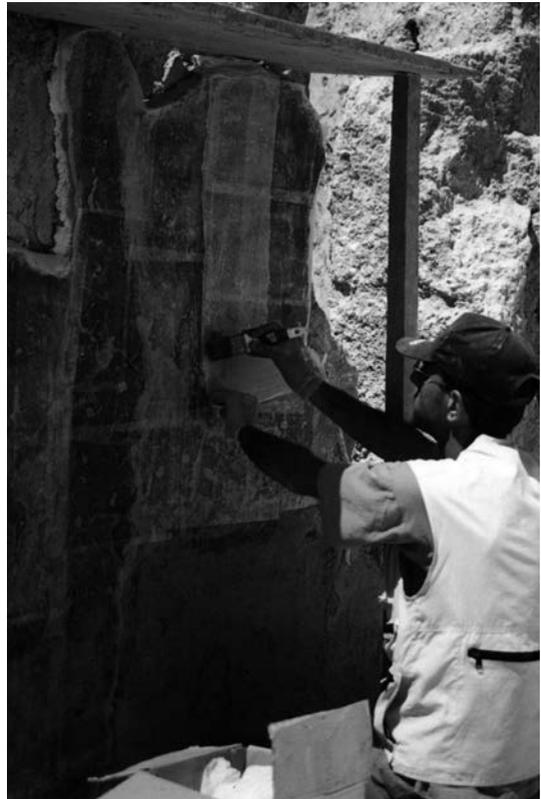
Fig. 5. Covering the surface with fabric (facing) (photo: C. Çetin).

The first step to prepare the wall paintings for lifting was to apply a protective cover (a 'facing') to the surface of the paintings, to protect the fragile decorations during transport. This 'facing' consisted of Japanese tissue and gauze of a Paraloid B-72 solution (20-25 % in acetone) (Fig. 5). Japanese tissue was used as an intermediary layer to protect the surface of the pigment layer. It was applied on the surfaces in pieces of 10 x 10 or 15 x 15 cm. The adhesive resin was applied *through* the tissue in order to assure a constant, uninterrupted application. The

gauze was applied on the surface in two overlapping layers [because of the large dimensions and weight of the panels and was applied in small portions only to facilitate an easy application and later removal.

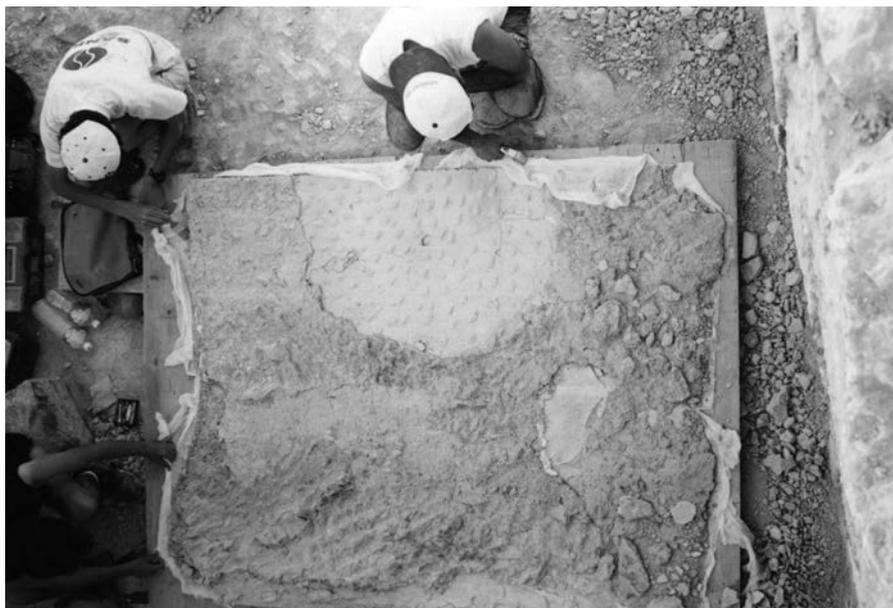
Fig. 6. Attachment of the wall painting to the temporary wooden panel (photo: S. Şener).

The removal was done extremely carefully, using long, thin steel chisels to separate the mortar from the walls, whereas the edges of the paintings (mostly the lower parts of the paintings, since the upper edges ended where the wall had collapsed and thus was easier to remove) were cut loose with fine stone chisels. After removing the paintings from the walls, they were fixed onto wooden transport panels or carriers by means of attaching the edges of the paintings to their wooden transport frames (Fig. 6).

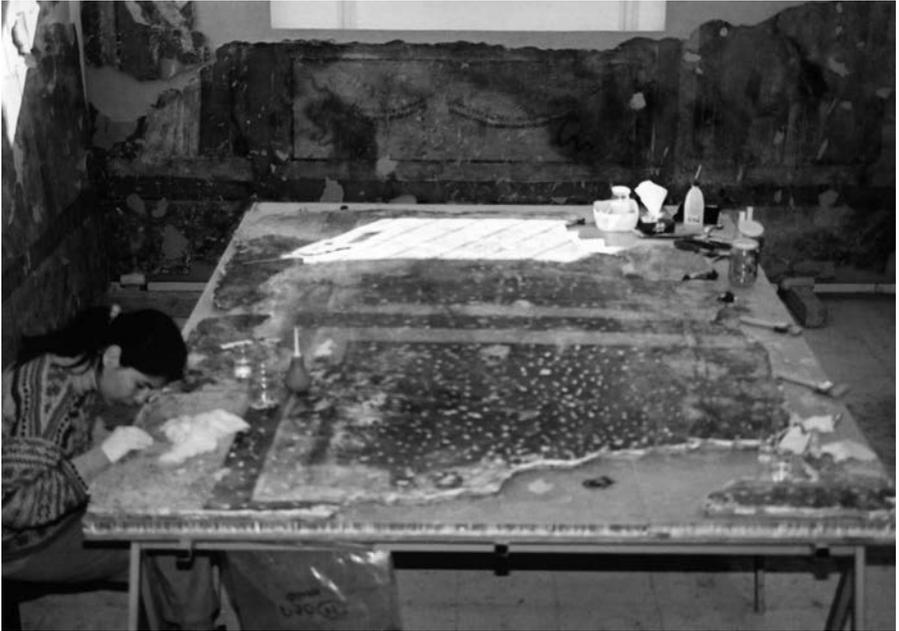
Fig. 7. Cleaning studies on the pigmented (front) surface (photo: B. Eskici).

With the back surfaces fixed with synthetic mortar, the wall paintings were turned over and the front surfaces were treated. The temporary protective layers (Paraloid, Japanese tissue, gauze) applied during the lifting and carrying process at Zeugma were removed by softening with paper towels and/or cotton padding soaked in acetone. Facing removal took place with no damage to the pigmented surface. Soil, sediment, and contamination layers on painted surfaces were cleansed mechanically and with solvents (water, alcohol, and acetone) (Fig. 7).

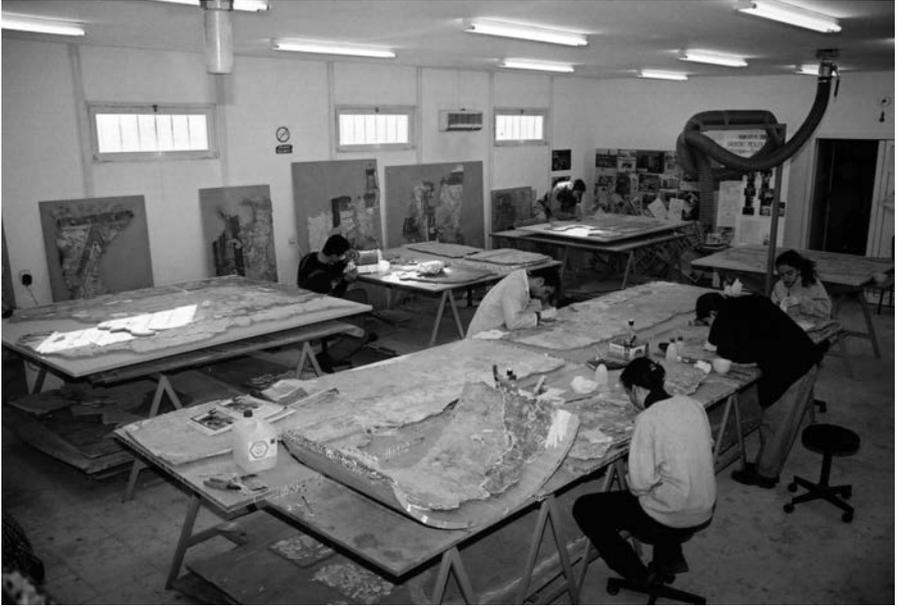
Fig. 8. Scene from laboratory studies (photo: B. Eskici).

The paintings were fixed on *Aerolam* panels¹⁰ designed to reflect the original position of the paintings (Fig. 8). The panels were prepared with consideration for details such as the dimensions of the paintings, their height from the ground, windows and niche openings, and joining points at the corners. The positions of the wall paintings were indicated with an acetate pen on the new carrying panels prior to the adhesion process by laying the paintings on the panels and making a one to one tracing. The paintings were then removed from the panel and the adhesive was applied within the reference lines. The wall paintings were placed on the panels and the superfluous adhesive was cleaned with cotton soaked in alcohol. Epoxy resin (Araldite M/HY-956 in 5:1 ratio: Moreno 1997, 305; Bingöl/Pracher 1997, 333; Pedroso 2002, 53) was used as the adhesive and quartz sand was added to the compound in order to increase the viscosity of the mixture.

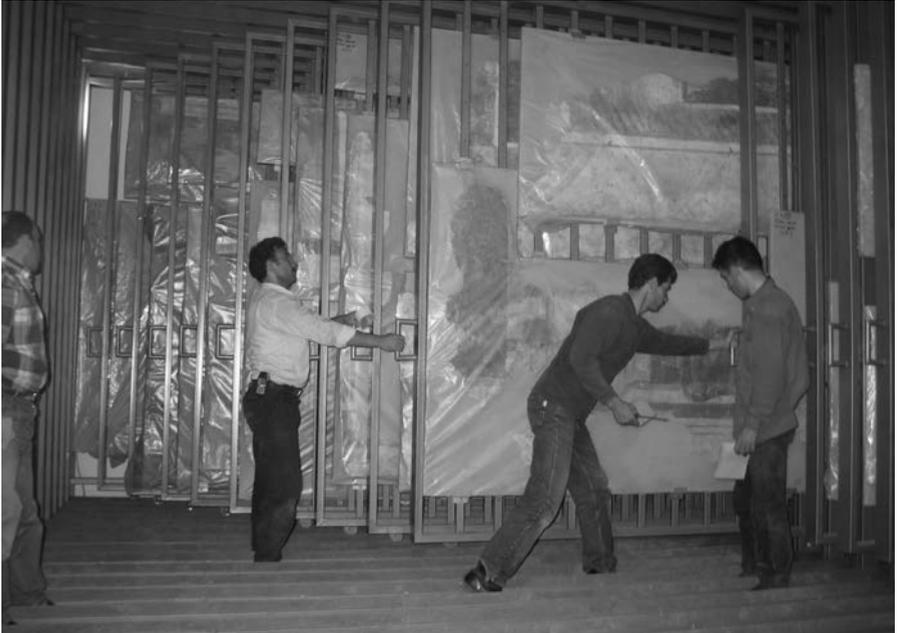
Fig. 9. Wall painting panels placed on the guide shelves (photo: S. Şener).

The storage installation consists of 22 vertical shelf systems (3 x 5 m each). The shelves can easily move along the guiding wheels on the ground and on the ceiling (Fig. 9). The guides and supports are made of iron whereas the support clasps on which the artefacts rest are in steel. The shelves can carry more than one wall painting in a vertical direction. A photographic inventory system has been installed on each shelf.
